UNITED STATES ENVIRONMENTAL PROTECTION AGENCY
REGION 5
77 WEST JACKSON BOULEVARD
CHICAGO, IL 60604-3590

Subject: U.S. EPA Comments on July 9, 2013, Response To The United States
Environmental Protection Agency for Blue Lake Campground

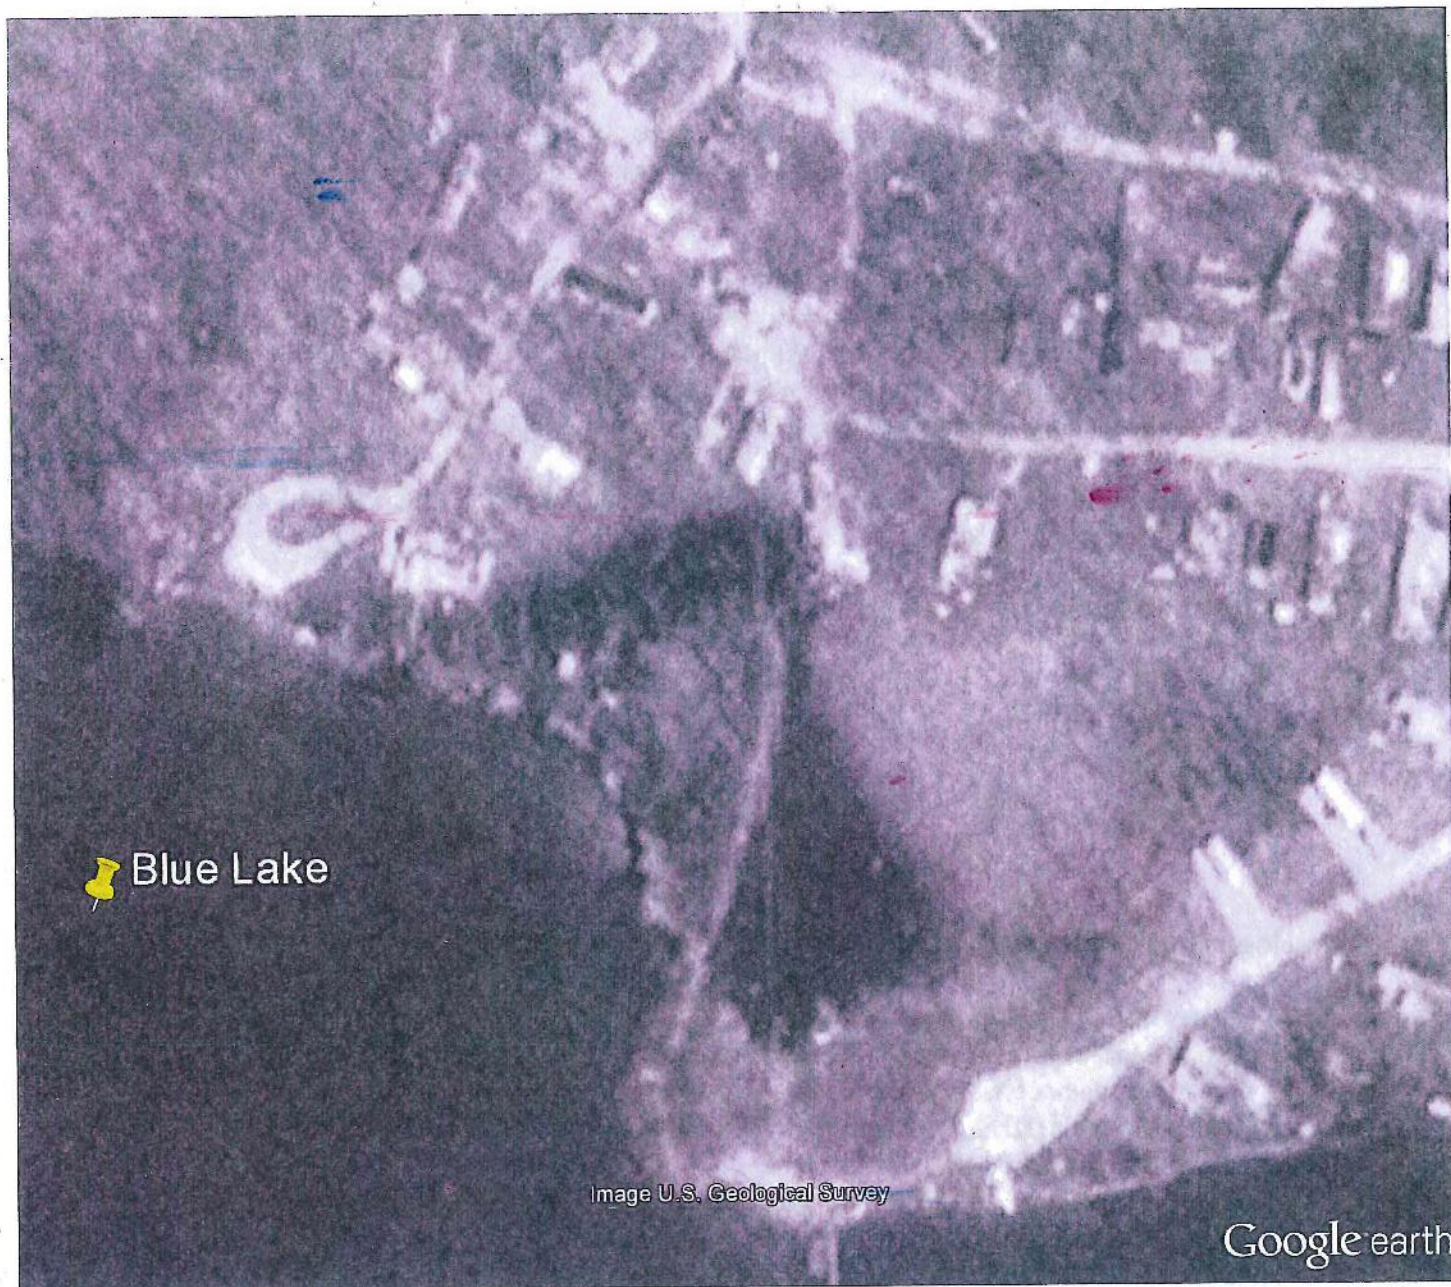
Image Date: APRIL 5, 1998

There are many other aerial photographs that corroborate the March 31, 2002, U.S. Geological Survey aerial photograph (see the enclosed 1998 photo, 2003 – Exhibit 2 in the Order (for the area east of the thumb shaped/vegetated wetland), 2005 – Exhibit 3 in the Order, 2006 – Exhibit 5 to the Order (for the area east of the thumb shaped/vegetated wetland), 2007 – Exhibit 6 to the Order (for the area east of the thumb shaped/vegetated wetland) and Exhibits 8 – 10 (for the area east of the thumb shaped/vegetated wetland)). In addition, the Order's Exhibits 2 – 8 show the area west of the northmost cul-de-sac in trees, not in fill and that includes the leaf off aerial photographs. Our interpretation of these aerial photographs, show signatures of wetness before and after your purchase of the property for the wetland areas to the east and south of the thumb shaped/vegetated central wetland.

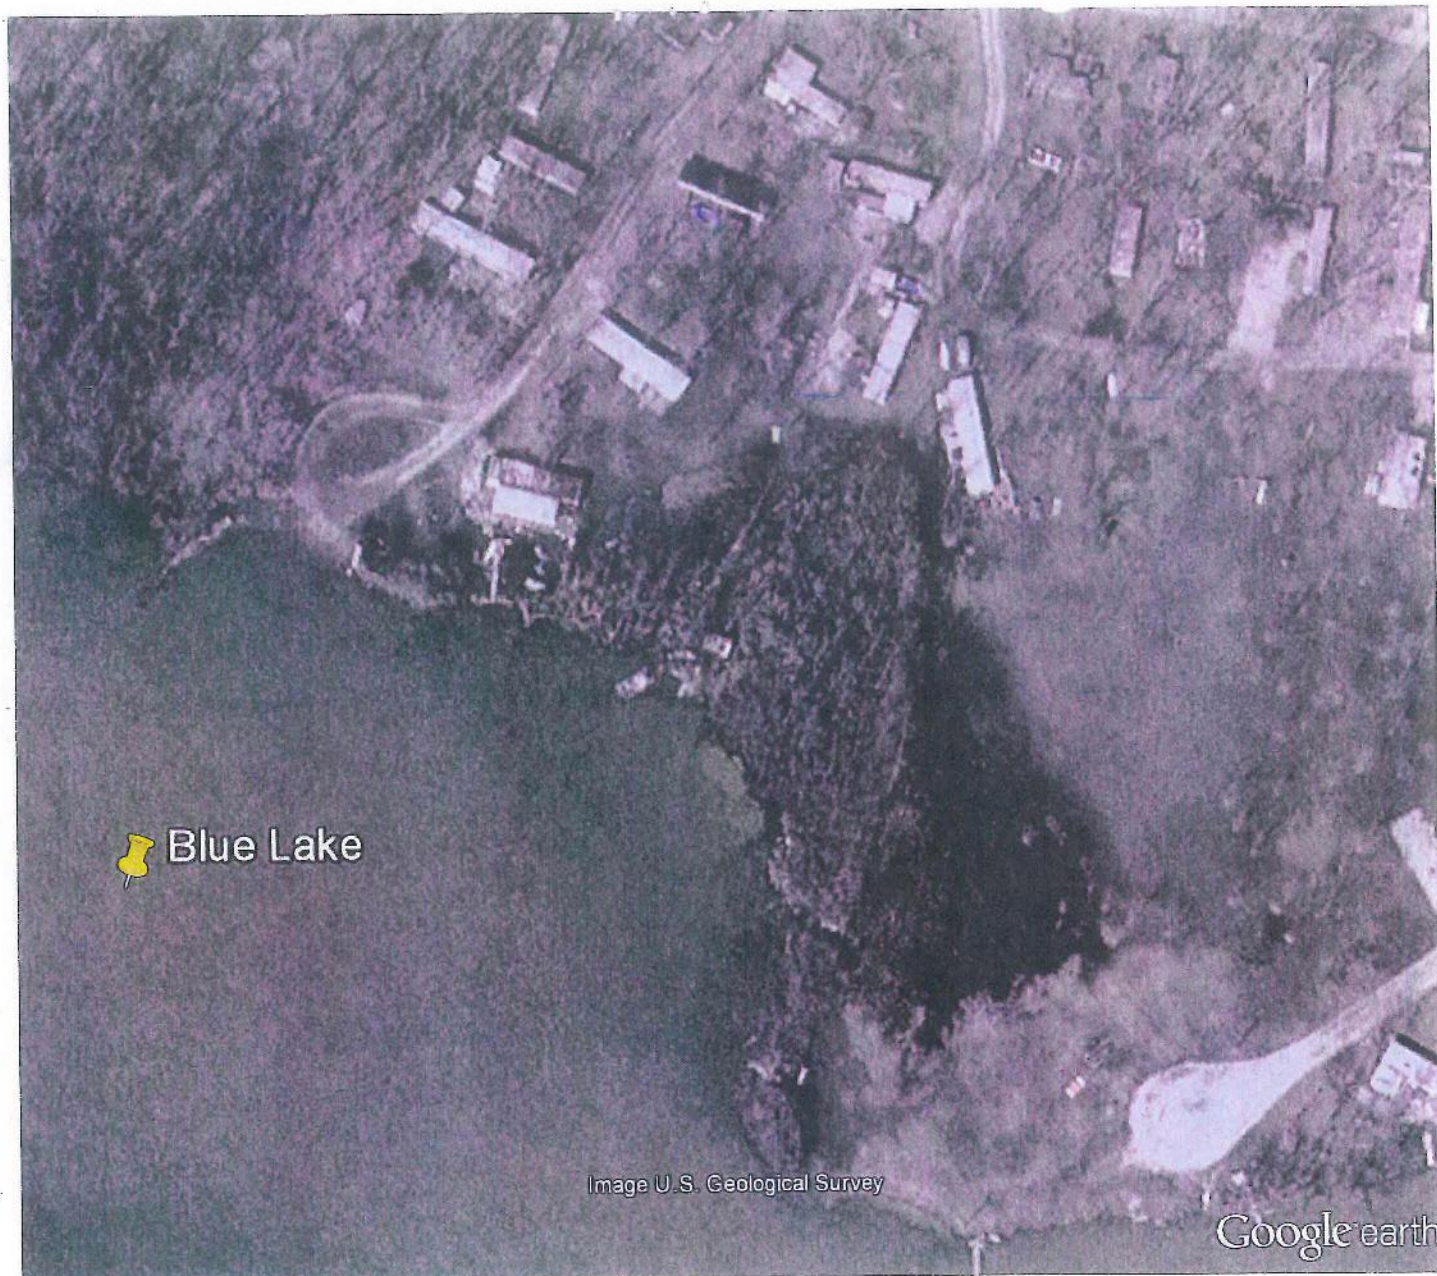
Image Date: March 31, 2002

Regarding your argument that the site's prior history of disturbance eliminated site wetlands, the record, including information you supplied, does not support your conclusion that all site wetlands were so disturbed by the actions of the prior owner, that they would be classified as 'upland'. The enclosed March 31, 2002, U.S. Geological Survey aerial photograph (leaf off), taken less than a month after your purchase of the property, serves as a baseline and is in apparent contradiction to your assertions. The area north of the northernmost cul-de-sac seen in this image shows no development west of the cul-de-sac and it is vegetated – this is where you have currently placed four trailer units atop fill material. A thumb shaped and vegetated wetland is apparent in the photo's center (its central core remains today) and it appears to extend and

narrow to the west and waterward almost to the east edge of the aforementioned cul-de-sac – this is where you have filled on its three sides for trailer pads, lawns and fire pits. Inundated areas, with little or no vegetation, exist to the east and south of the thumb shaped/vegetated wetland. In contrast, what appear to be recently filled areas exist immediately to the south and east where the gazebo and roadways now lie, respectively. It is relatively recent fill because there is no vegetation growing from it (this may be your beach area). EPA acknowledges that the thumb shaped/vegetated wetland has signs of disturbance within and on its borders, but these are small areas and appear largely to be structures and not fill material. If these disturbed areas are what you are referring to in your response, they are not part of EPA's allegations of discharges of fill material without a permit.

While EPA and the other permit agencies may permit some amount of older fill material to remain, all fill areas north of the northernmost cul-de-sac and all fill areas to the south and east

of the central thumb shaped/vegetated wetland (and west of the road and north of the gazebo road) should be restored. Any remaining fill material that may be permitted would need to be mitigated for.
